WT-1181

Operation TEAPOT

Projects 36.1 and 36.2

EXPOSURE OF MOBILE HOMES AND EMERGENCY
VEHICLES TO NUCLEAR EXPLOSIONS

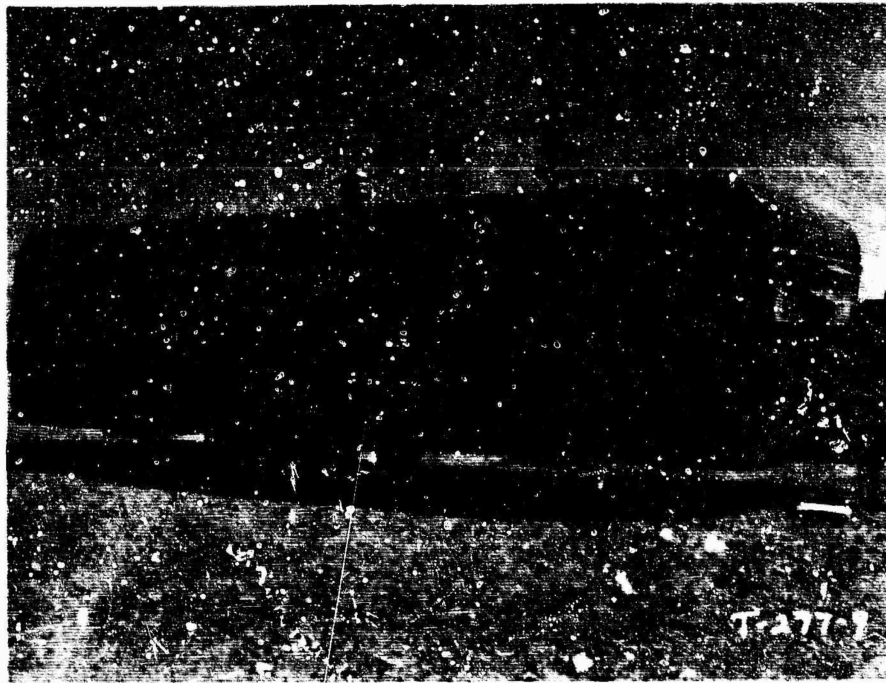
Exterior: Right side dished in; back end dished in; no ruptures on exterior; taillight off; trailer moved forward 12 in.; bent jack stem; front door dished in; no separation of floor and sidewalls. (See Fig. 2.6.)

Fig. 2.6—Exterior of Vagabond trailer after the blast.

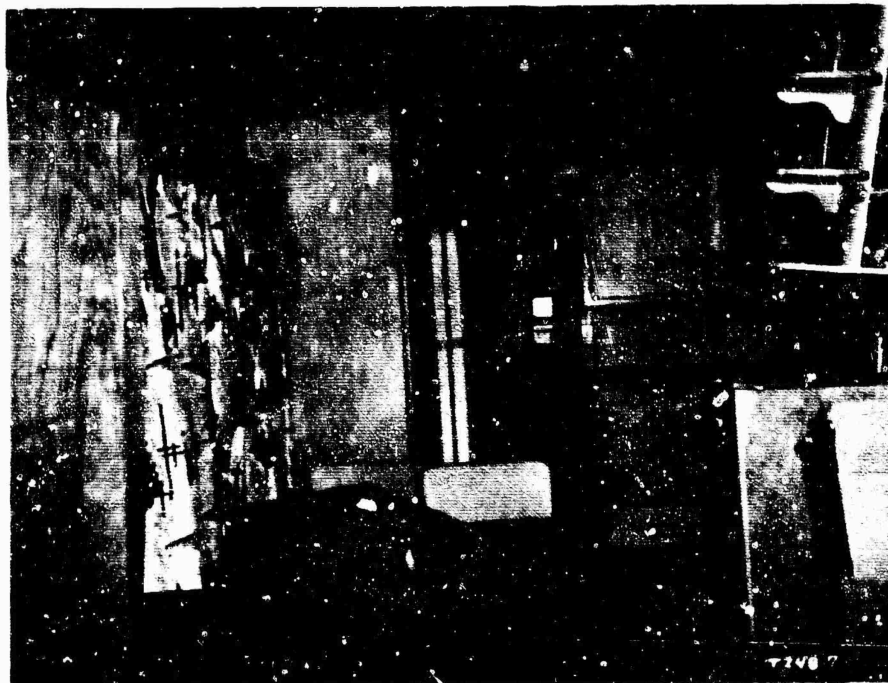
Interior: Ceiling bulged in slightly; front-door jamb inside torn loose; front overhead mirror broken; screen-door panel torn loose; galley overhead cabinet over stove torn loose; cornice box on left side of living room off; very little window glass inside; venetian blinds intact; no splits or ruptures in interior sidewalls; kitchen ceiling fixture hanging loose; rear windows, left front picture window, and left bedroom window broken; kitchen cabinets unhurt on both sides; sliding wardrobe door off; bathroom door off; lavatory off wall; all plumbing tight and operable; linen closet torn from bulkhead; rear bathroom bulkhead separated from floor; one tile off bathroom wall; rear wardrobe door off; rear panel molding off; light fixture in rear off; bathroom style off; light-fixture glass and mirror glass in bedroom broken; all side vents undamaged; stove, refrigerator, heater, divan, table and chairs, and beds unhurt. (See Fig. 2.7.)

Fig. 2.7—Interior of Vagabond trailer after the blast.

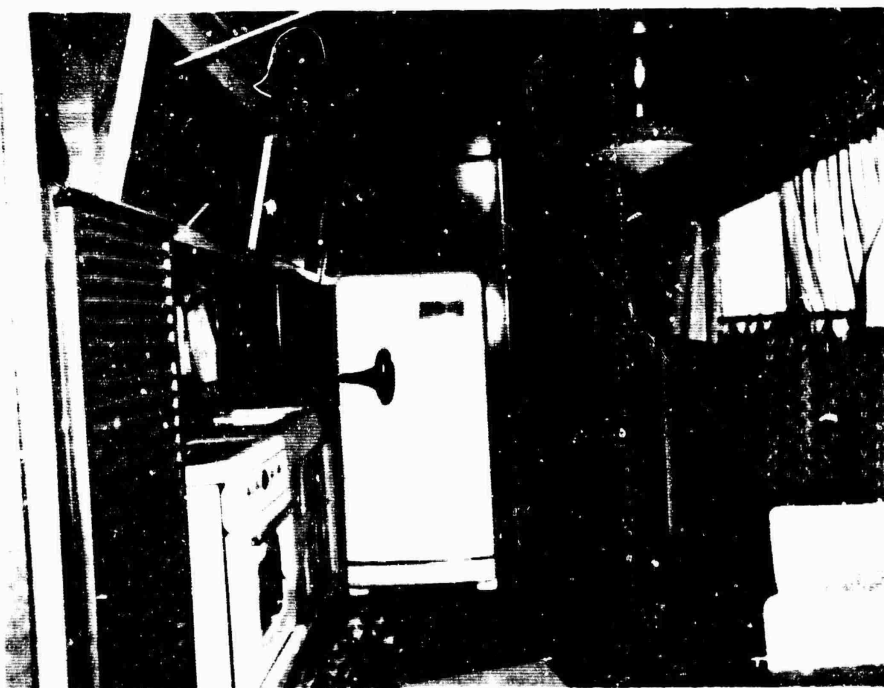
Interior: All doors of overhead cabinets in kitchen and living areas down; ceiling molding in kitchen down; kitchen overhead cabinets pulled from the ceiling and wall; front-wardrobe bulkhead dished in; fluorescent tube in kitchen broken (the only broken glass in the trailer); panel doors of sink cabinet out; thermostat loose on the wall; lavatory torn loose from wall in bathroom; toilet tank broken; all plumbing intact; front-bedroom bulkhead dished in; overhead cabinet upstairs loose from the ceiling; venetian blinds off; both upstairs and downstairs window frames pulled loose; three pieces of glass broken in jalousie windows and glass outside trailer; entrance-hall light hanging loose. (See Figs. 2.10 and 2.11.)

Fig. 2.10—Interior of Southwestern trailer after the blast.

Fig. 2.11—Interior of Southwestern trailer after the blast.

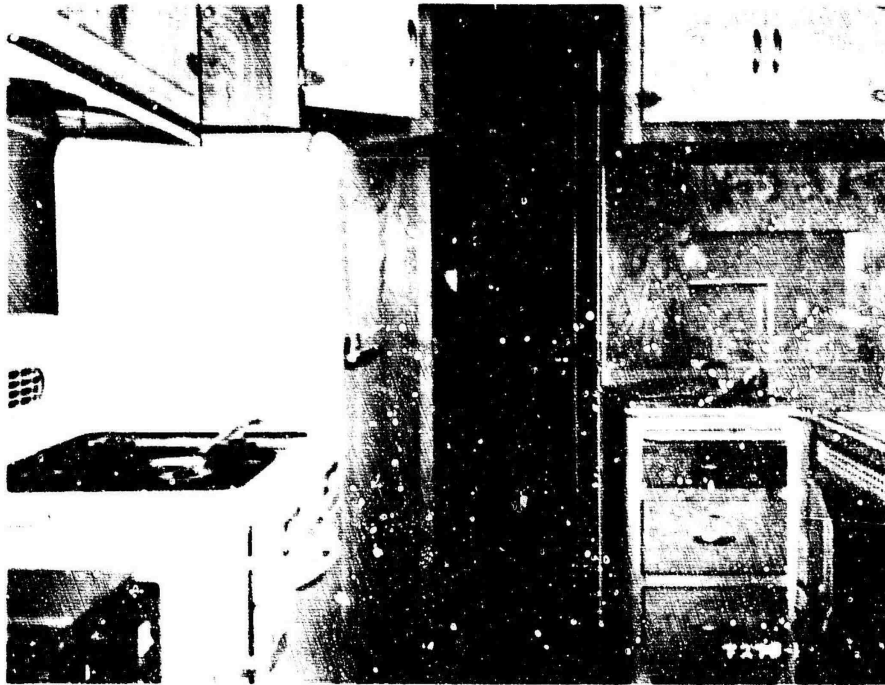
Interior: Style in center wardrobe broken; one piece of molding in living room bulged; heater door off; kitchen venetian blind off; left-side rear panel by window in bedroom split; lower right front window, lower kitchen window, and bedroom left-side window broken; no glass inside trailer. (See Figs. 2.14 and 2.15.)

Fig. 2.14—interior of Columbia trailer after the blast.

Fig. 2.15—Interior of Columbia trailer after the blast.

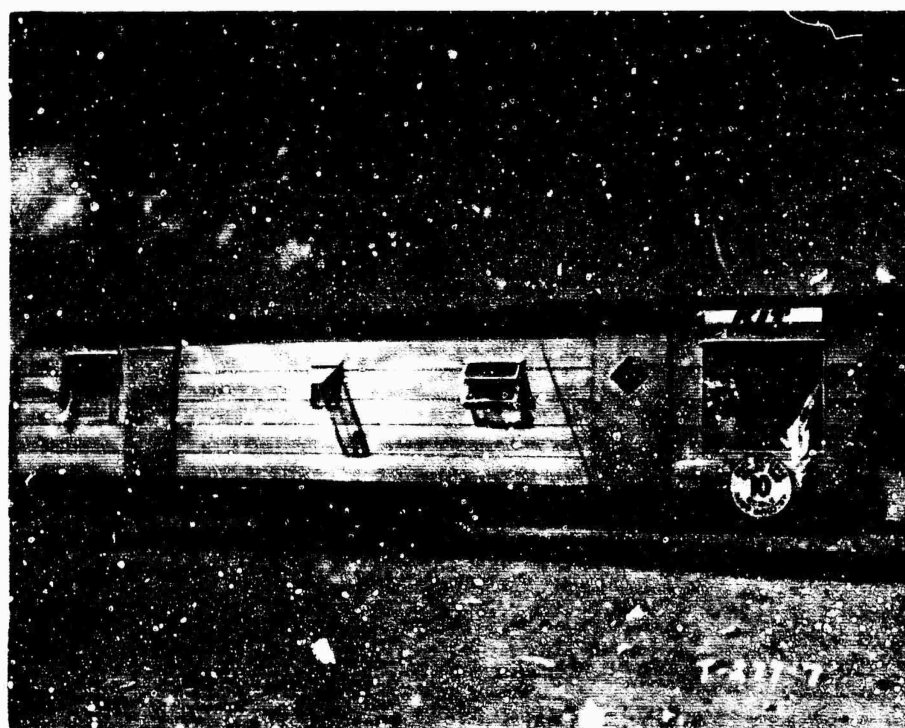
Exterior: Left lower panel partially out of channel; two panels on left lower side out of channel approximately 3 ft; overhang in front dished in; no rupture in roof; panel over left front window out of channel the length of the window; panels below taillight and below roof curve in rear out of channel. These panels out of channel could be easily and quickly repaired without tools. (See Fig. 2.17.)

Fig. 2.17—Exterior of Kit trailer at 10,500 ft after the blast.

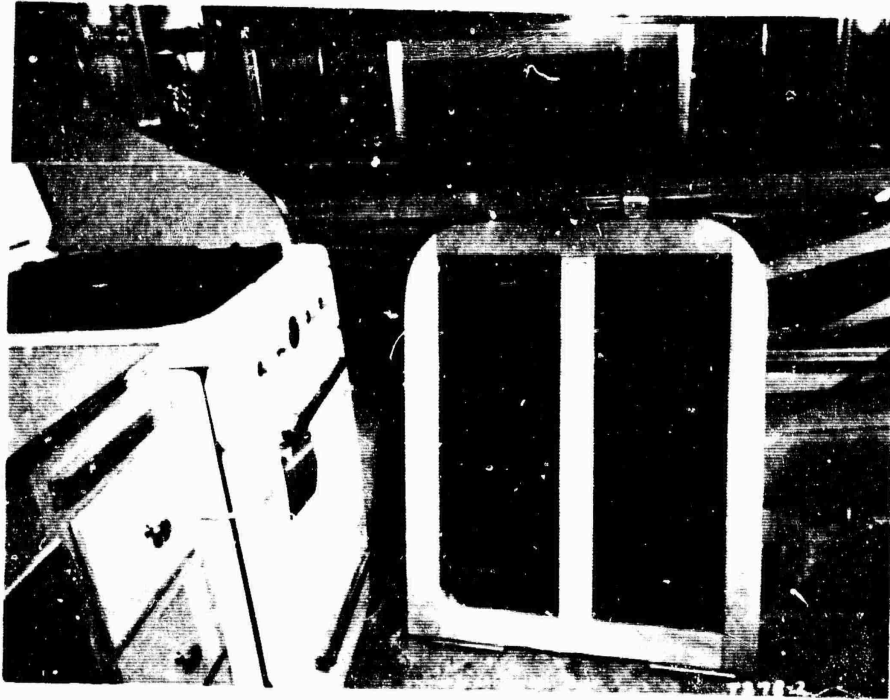
Interior: Dinette table down, with leg broken off; ceiling molding bulged down left front side; rear left bedroom venetian blind down; front left lower window cracked. (See Figs. 2.22 and 2.23.)

Fig. 2.22—Interior of Aljoa trailer after the blast.

Fig. 2.23—Interior of Aljoa trailer after the blast.

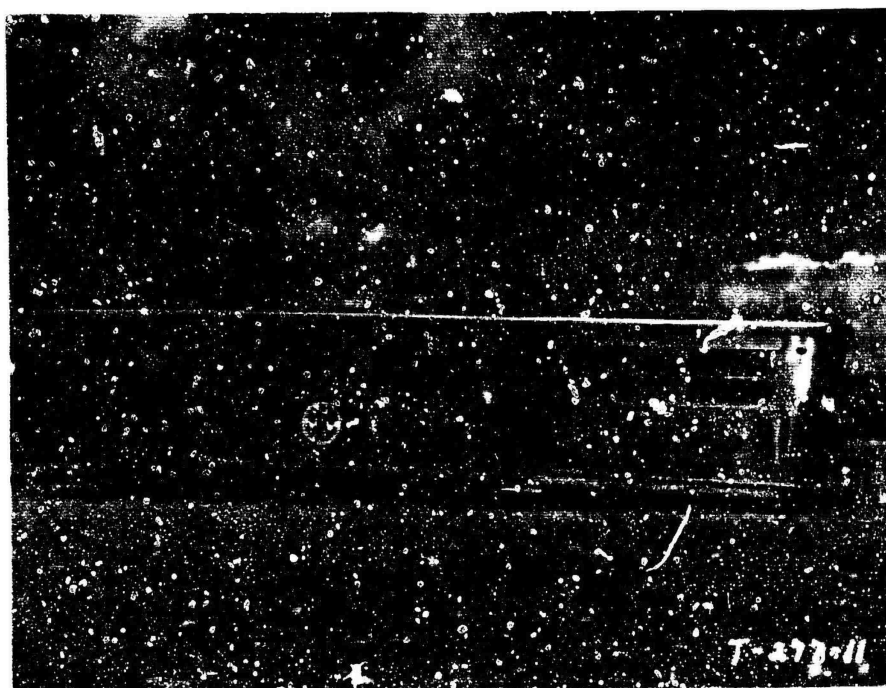
Fig. 2.25—Exterior of Spartan trailer at 10,500 ft after the blast.

Exterior: Front end dished in about 8 in.; left side dished in about 8 in. at living-room window; entire length of left side of trailer distorted; minor rupture of front roof, dented about 4 in.; no distortion of back and right side. (See Fig. 2.25.)

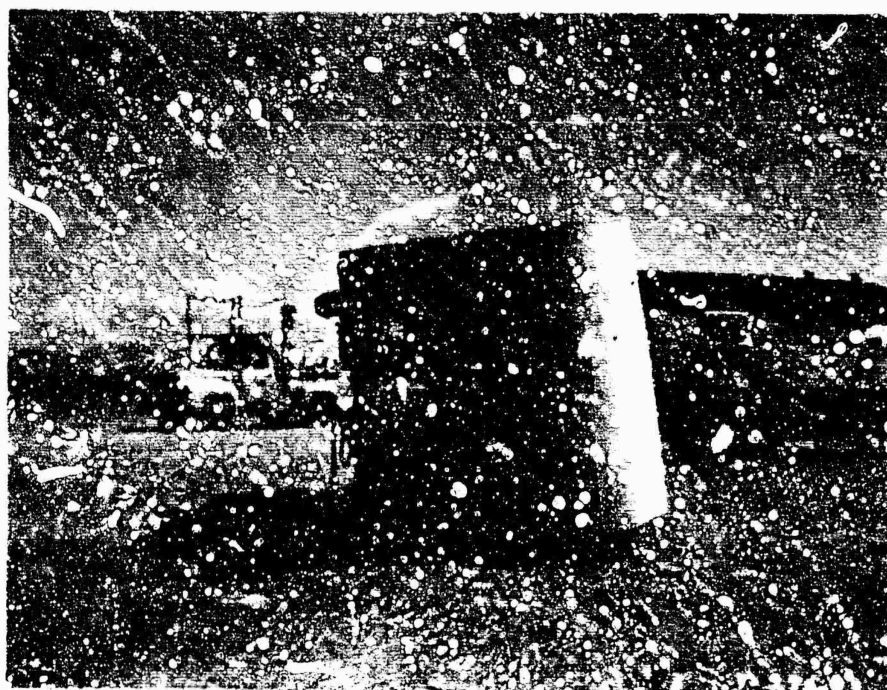
Exterior: Some distortion of left side; dents in rear roof, no ruptures. (See Fig. 2.29.)

Fig. 2.29—Exterior of used trailer at 10,500 ft after the blast.

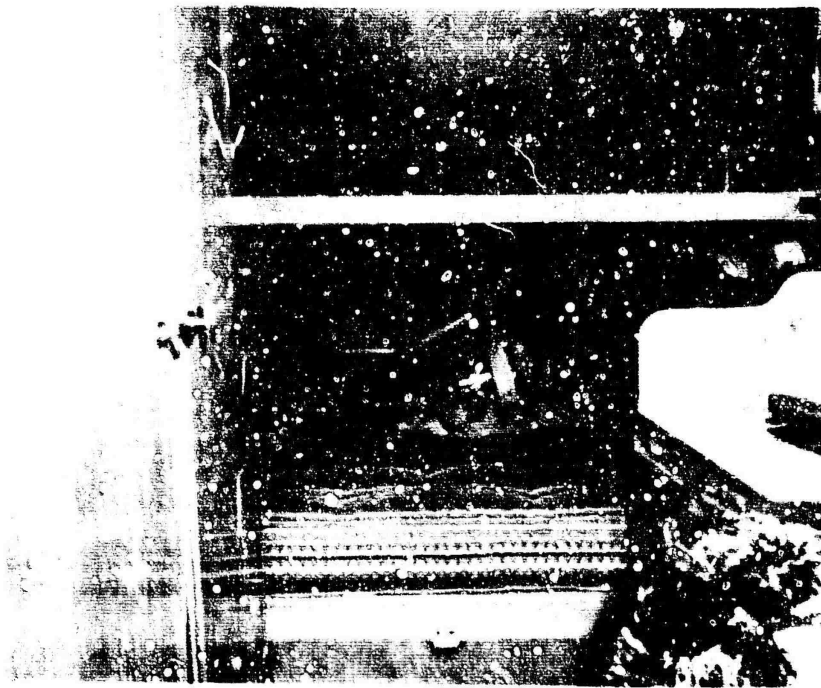
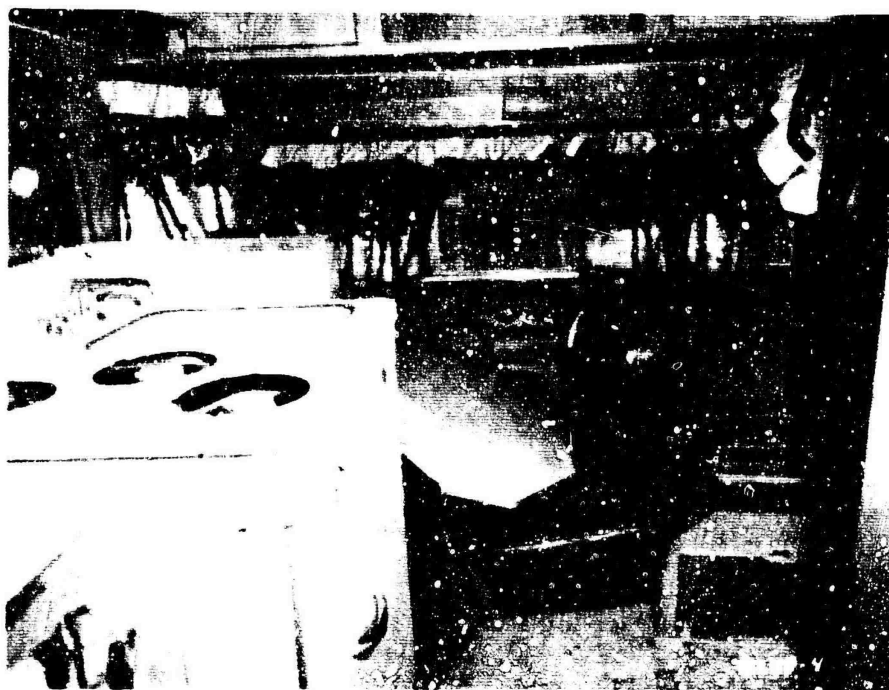
Interior: Ceiling molding off; ruptured panel above back window; butane light globe broken; wardrobe and overhead cabinet split slightly; table off wall; dinette cushion-wood assembly torn from wall and floor; all windows except front and right front side broken. (See Figs. 2.30 and 2.31.)

Fig. 2.30—Interior of used trailer at 10,500 ft after the blast.

Fig. 2.31—Interior of used trailer at 10,500 ft after the blast.

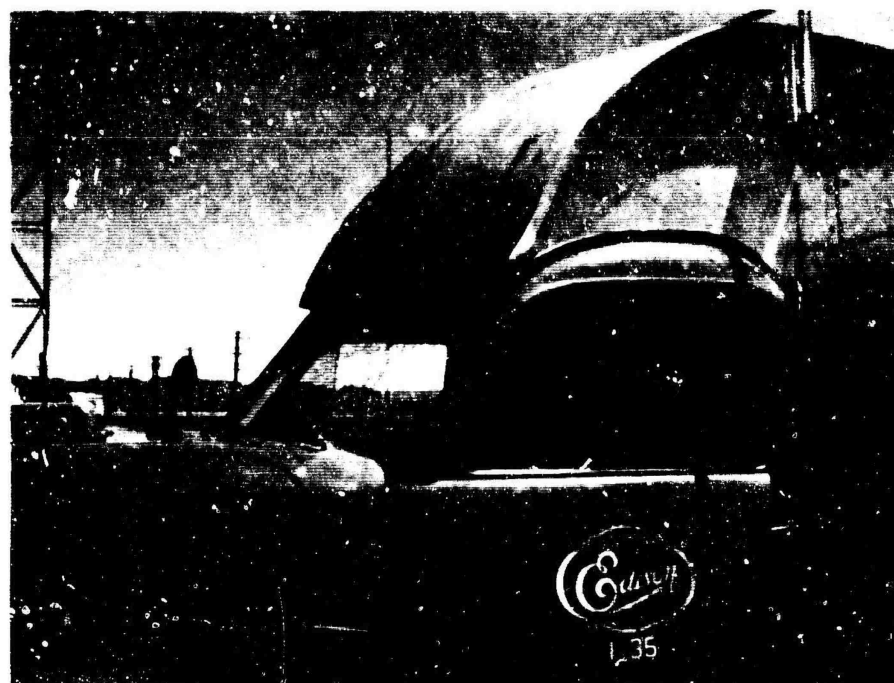
Test Results: The windshield was shattered. The rear window of the cab and two side windows on the truck were cracked; one side panel was dished in. Tools and equipment were not damaged. This vehicle would have been available for emergency operations. (See Fig. 3.10.)

Fig. 3.10—Shattered glass in light-duty electrical service truck.

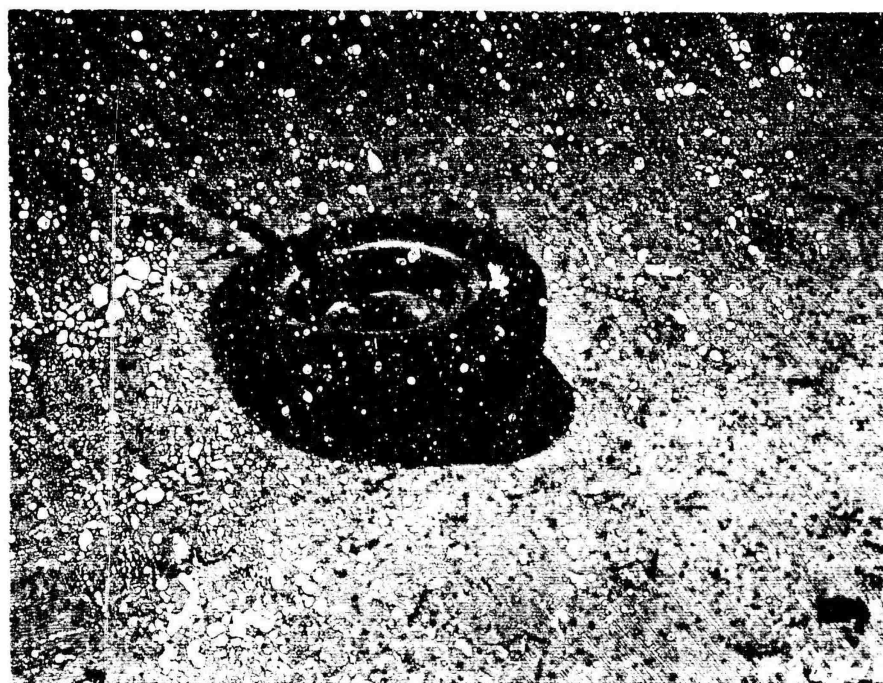
Test Results: Only one wheel and part of an axle were found after the blast. (See Fig. 3.17.)

Fig. 3.17—Remains of rescue truck after the blast.
